USA  
9 Dean Dr.  
Cartersville, GA 30121  
P: 800-536-5908 F: 770-386-3079

Canada  
6767 Invader Crescent  
Mississauga, ON L5T 2B7  
P: 888-564-7904 F: 905-564-2450

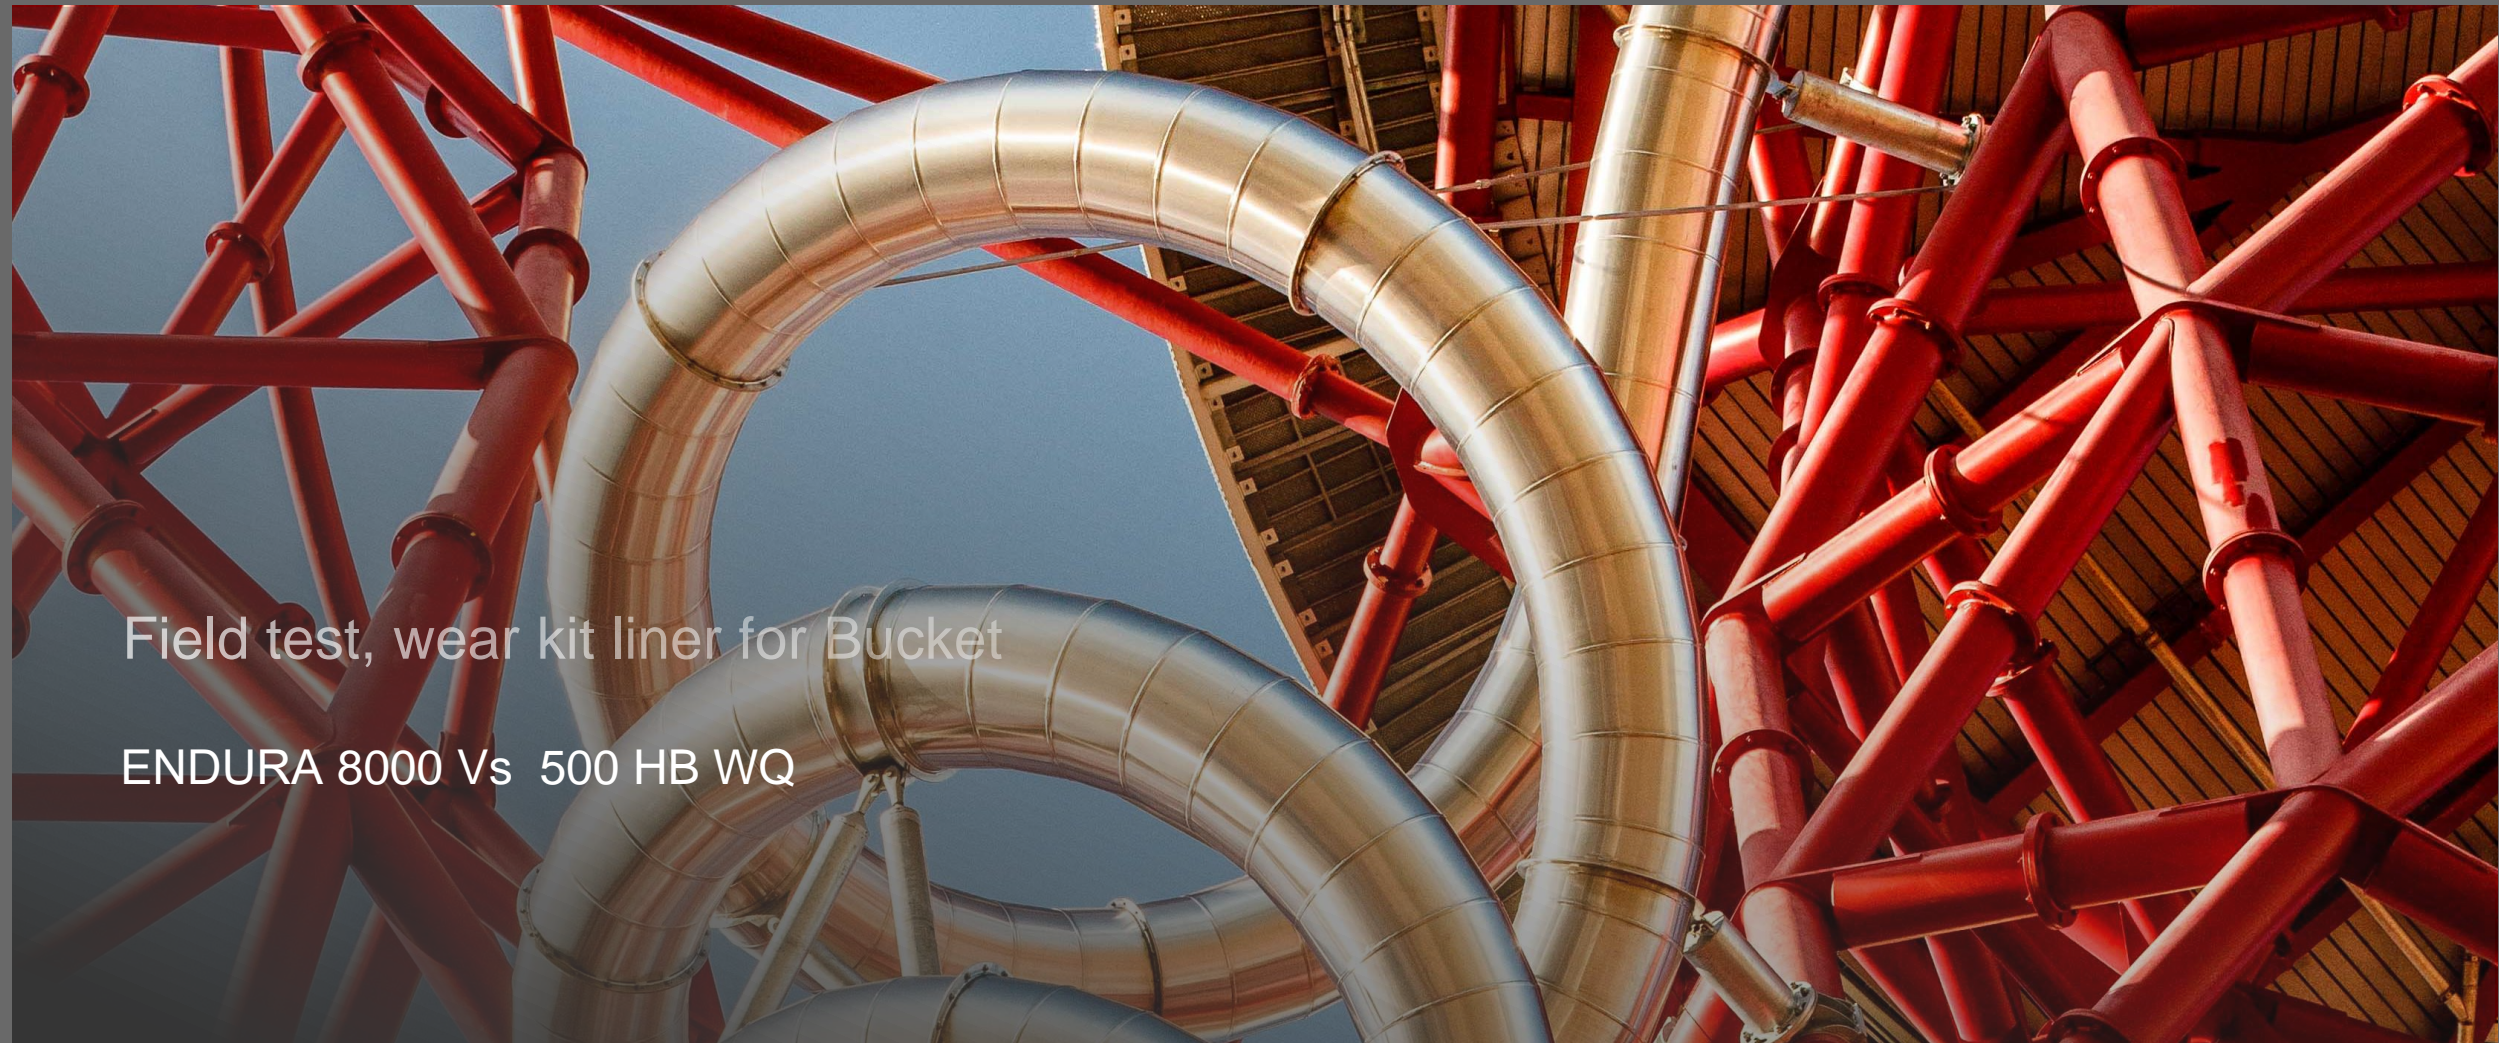
Field test, wear kit liner for Bucket

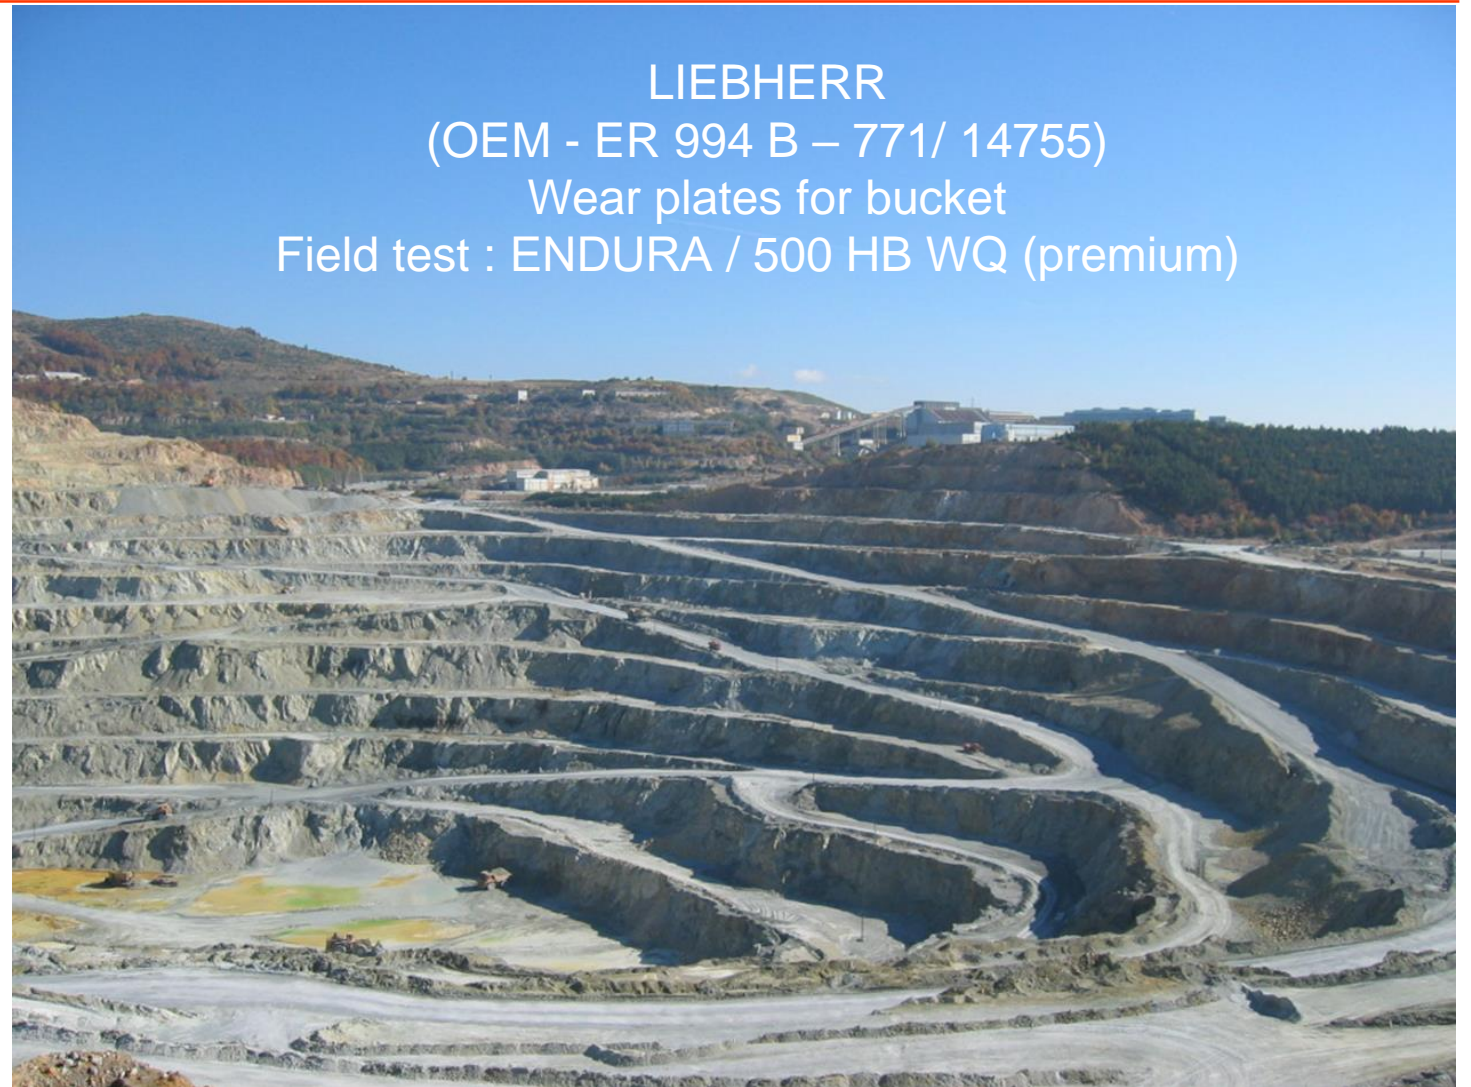
# Field test, wear kit liner for Bucket – ENDURA

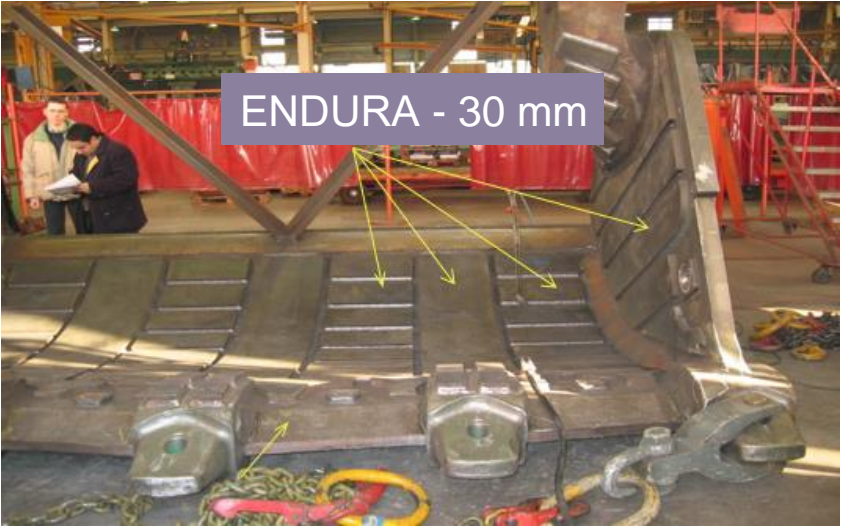
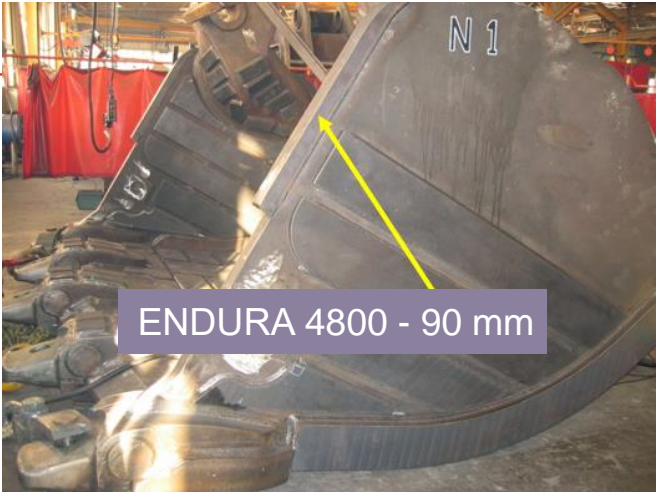
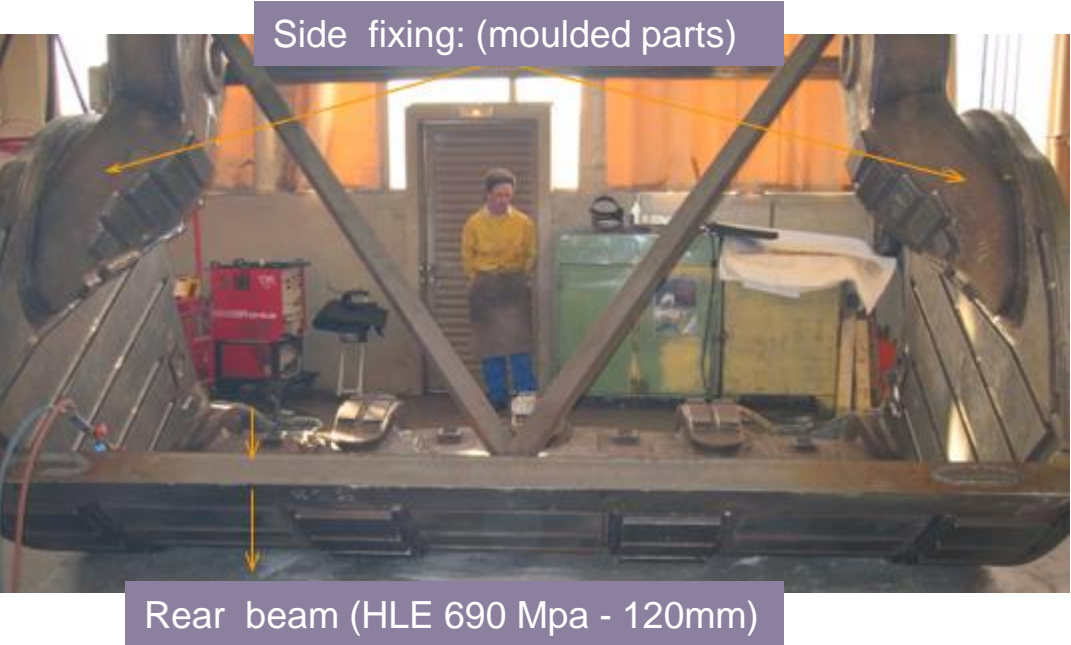
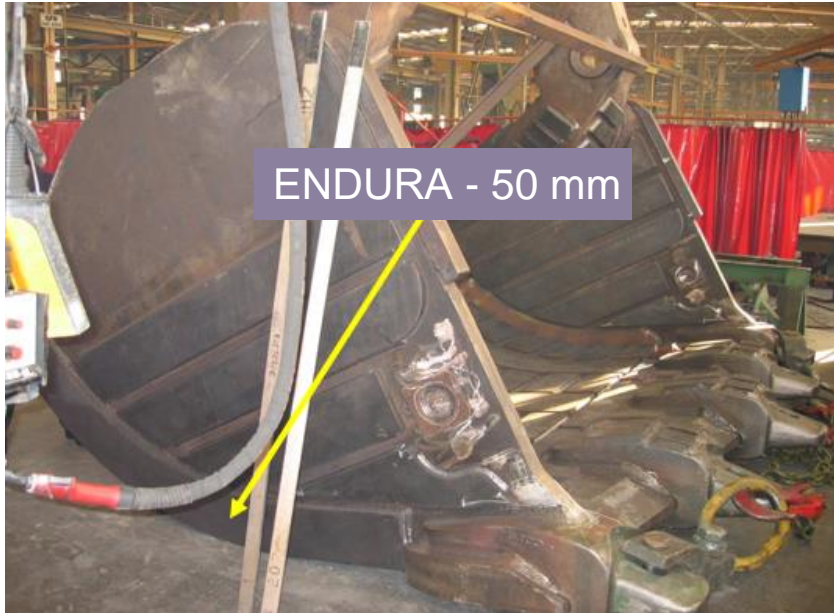
## Field test, wear kit liner for Bucket – ENDURA

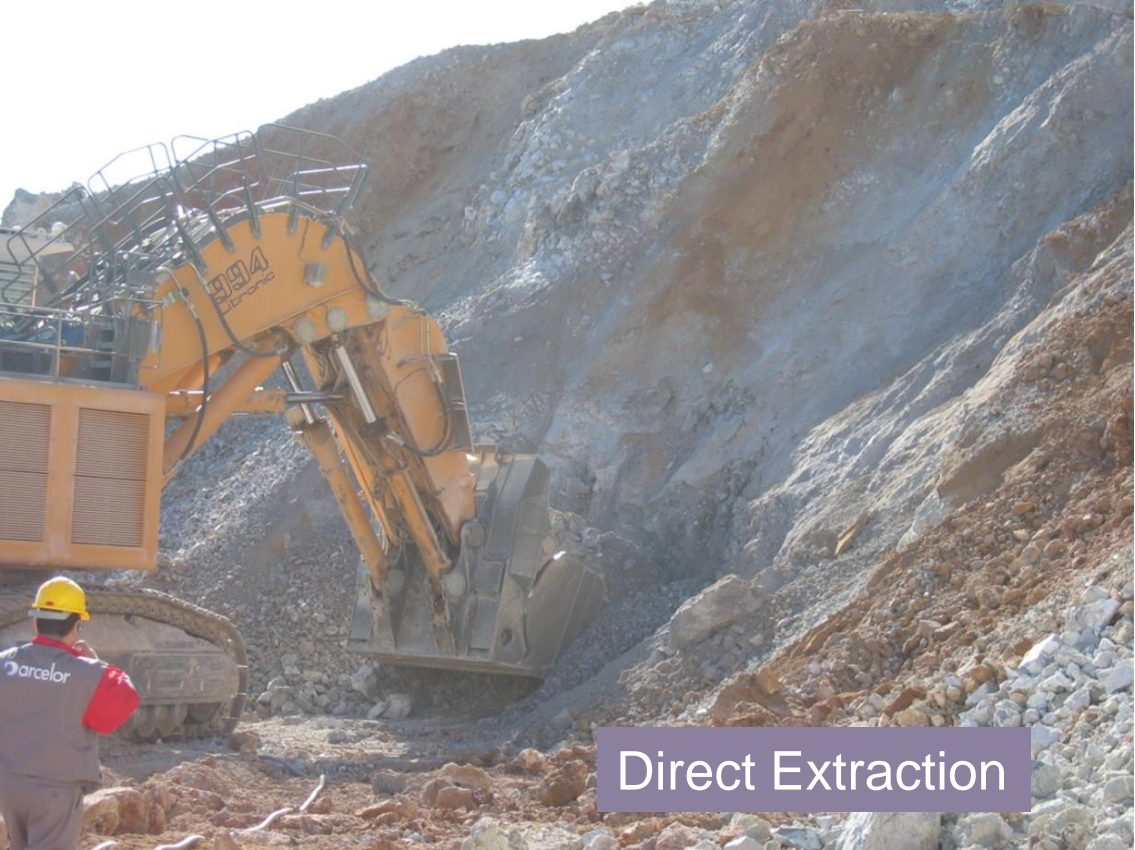
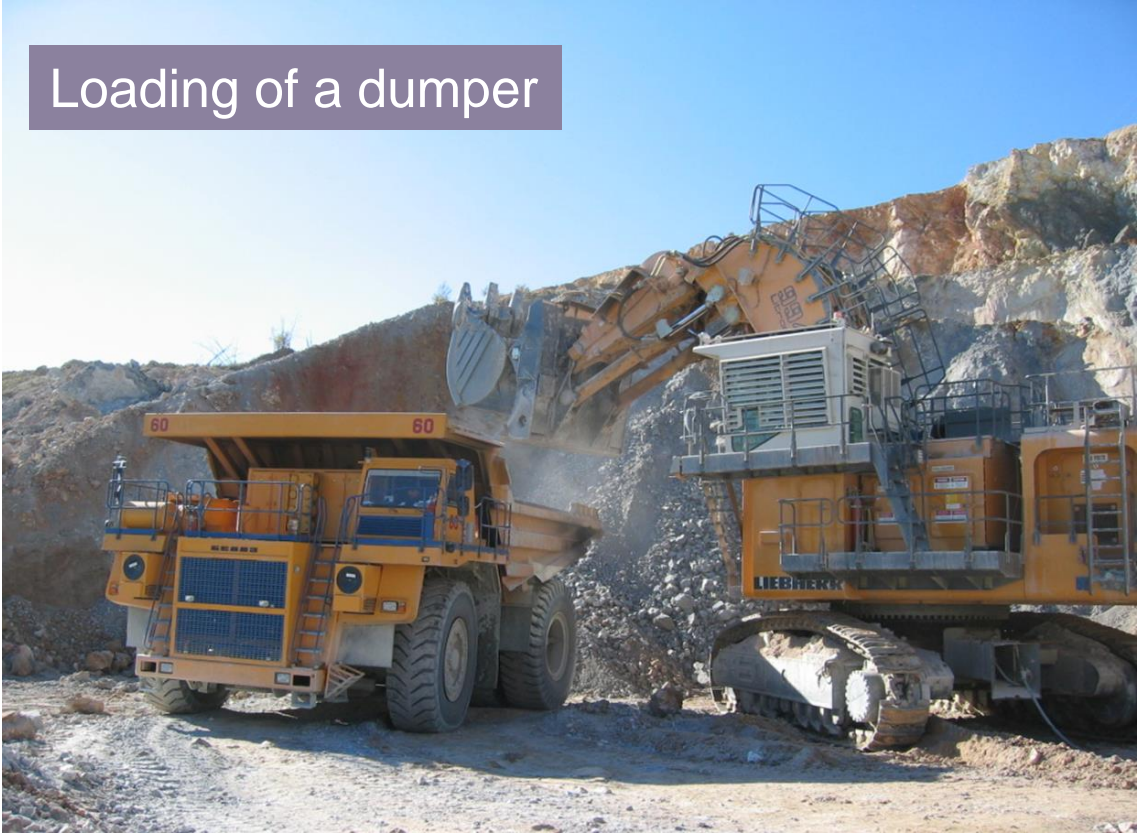
# Field test, wear kit liner for Bucket – ENDURA

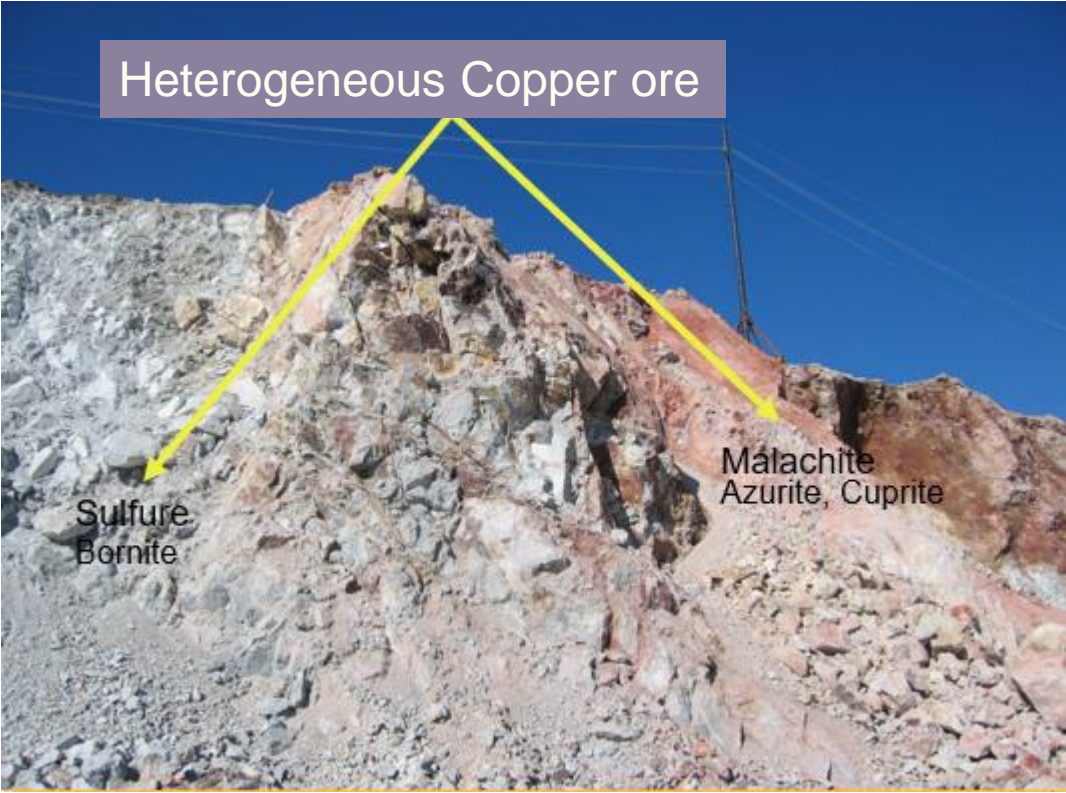
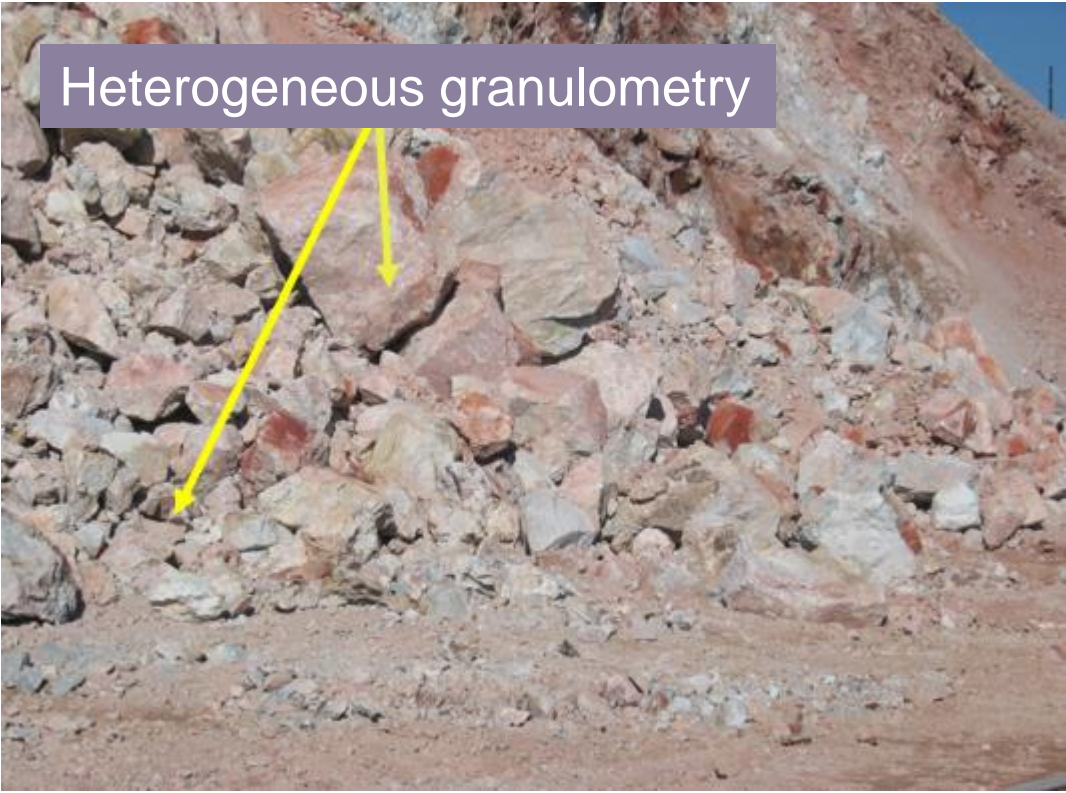
# Field test, wear kit liner for Bucket – WQ 500 HB bucket

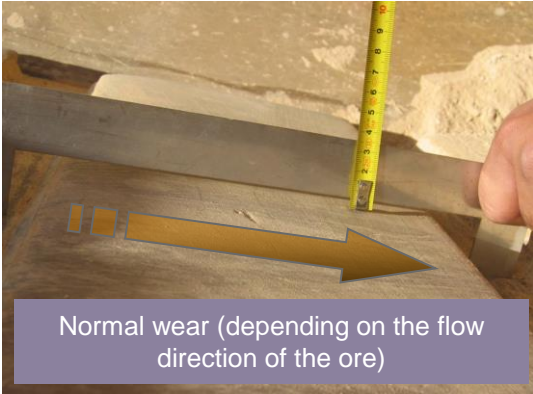
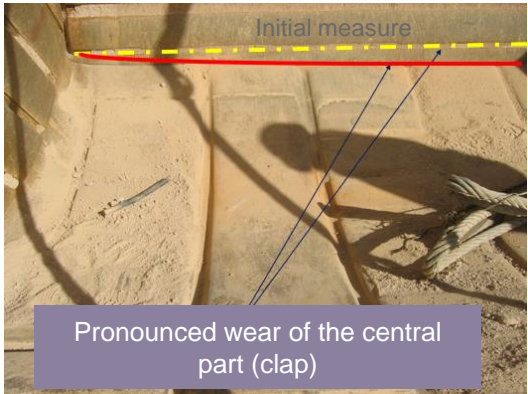
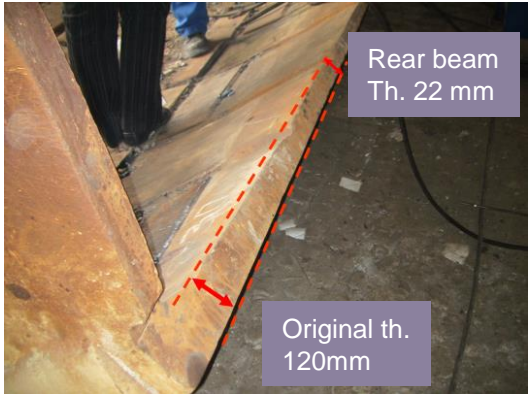
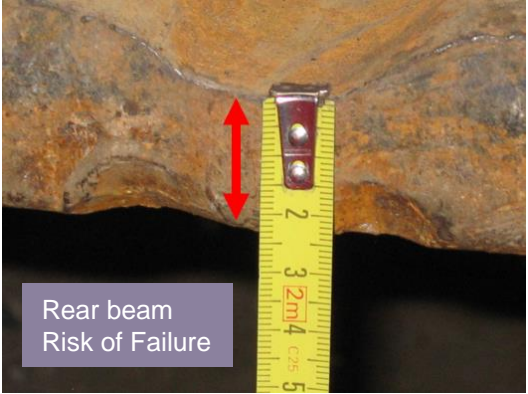
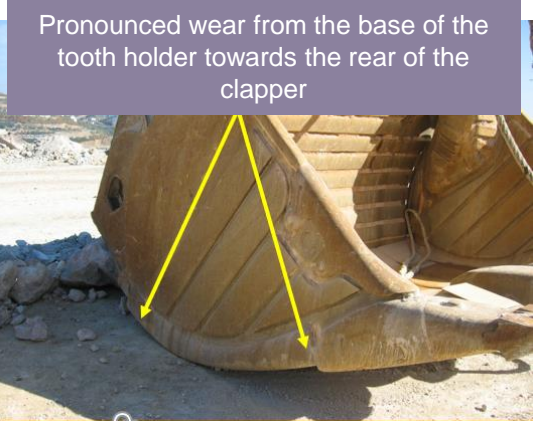
Bucket N ° 2  
abrasion kit – WQ 500  
**Shutdown for repair after 2540 H**  
Service period April - October 2005 (dry period)

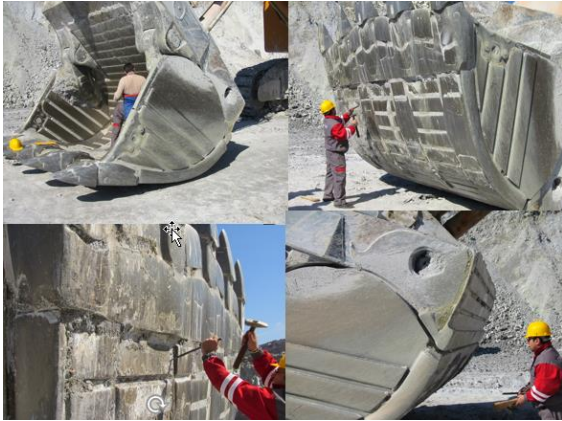
# Field test, wear kit liner for Bucket – ENDURA bucket

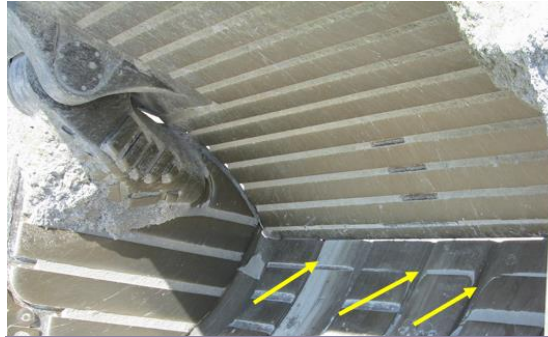
the improved wear resistance of the ENDURA parts limits the loss of sealing in the rear part. However, the unprotected areas (HLE structure) continue to undergo pronounced wear (digging in the direction of flow of the material).

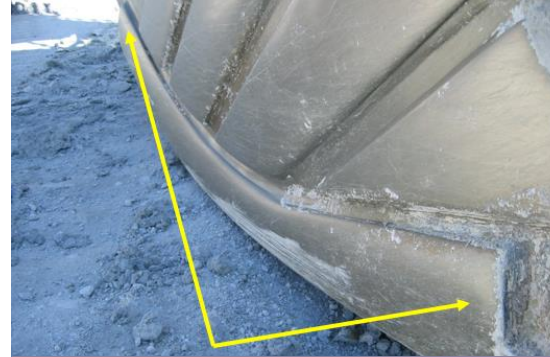
Although the wear is less pronounced, we find the whistle shape imposed by the design and mode of use of the bucket ...

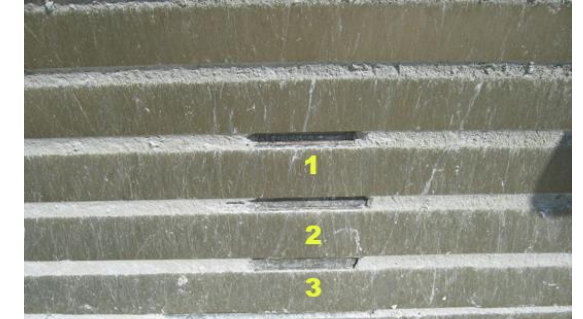
The protective plates located in the lower part of the rear hatch show no visible wear ...

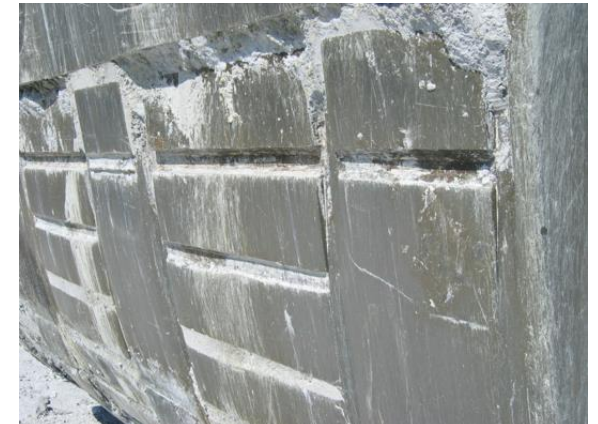
The upper surface of bucket N° 1, subjected to tangential abrasion under very high pressure, does not show any pronounced wear ..
