ENDURA Wear Solutions

ENDURA 80mm Grizzle Decks handle Hard Rock Impact Abrasion

Case Study 2010 - 2016

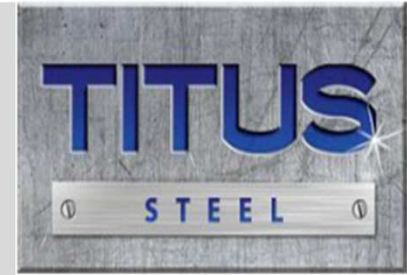
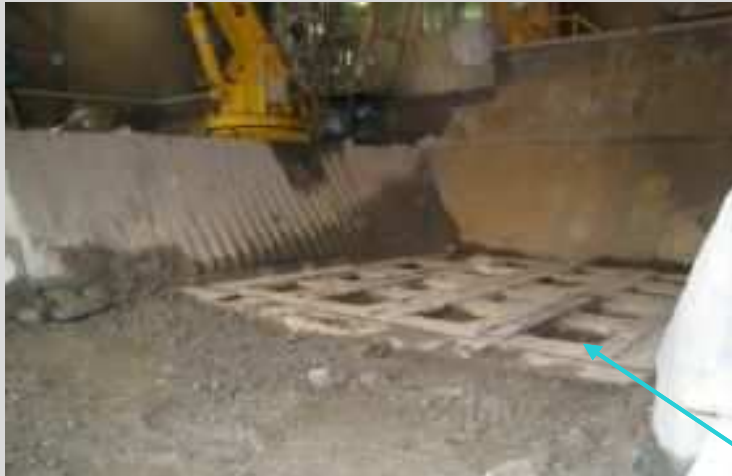
ENDURA 50mm thick grizzle wear bars caps replace traditional 450 HB wear material and extend service life in Kalgoorlie Gold Mine by over 200%

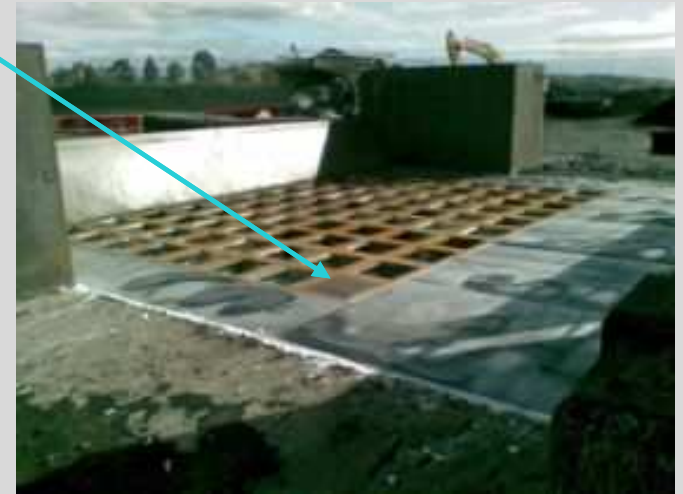
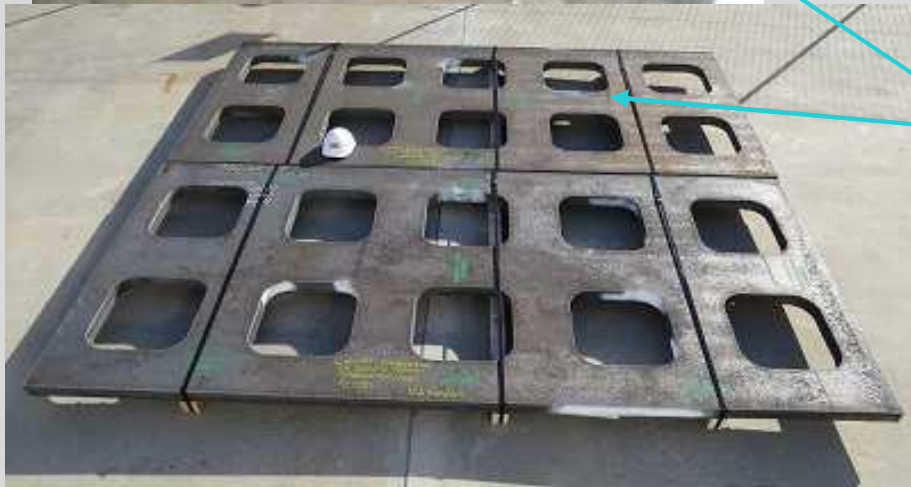
ENDURA 80 mm thick grizzle replaced previous 450 HB wear plate increasing service life by 400%

The original Rosebery Zinc Tasmania Grizzle manufactured from 450 HB wear plate suffered from high wear rates and fatigue cracking . Routine weld repairs required to maintain the 450Hb grizzle deck in operation .

The current ENDURA 80 mm grizzle decks have been in service for over 5 years with minimal wear and no fatigue crack issue .
