ENDURA

Extreme Impact and Abrasion Conditions

A Mining Industry Case Study Titus Steel's ENDURA greatly outperforms Hardox 500

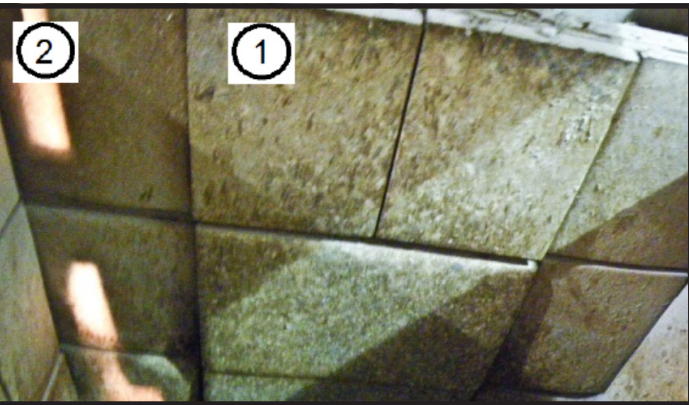
In an underground gold mine located in Quebec, Canada, the gold ore hits wear plates shown in the pictures. All liners were originally Hardox 500 plates 1.5" thick.

The higher concentration of material hammering the middle of the wall was forcing the replacement of the middle plate (1) significantly earlier than the side plates (2). Several extra maintenance interventions were thus required to replace the middle (1) liner.

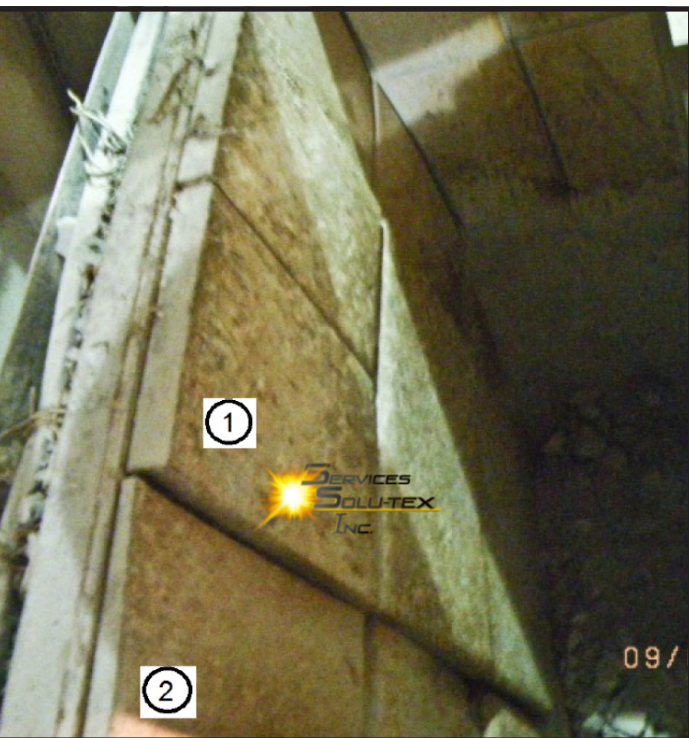
ENDURA was substituted for Hardox 500 on the middle liner (1) in the fall 2011 while the side plates experiencing LESS abrasion (2) remained in Hardox 500.

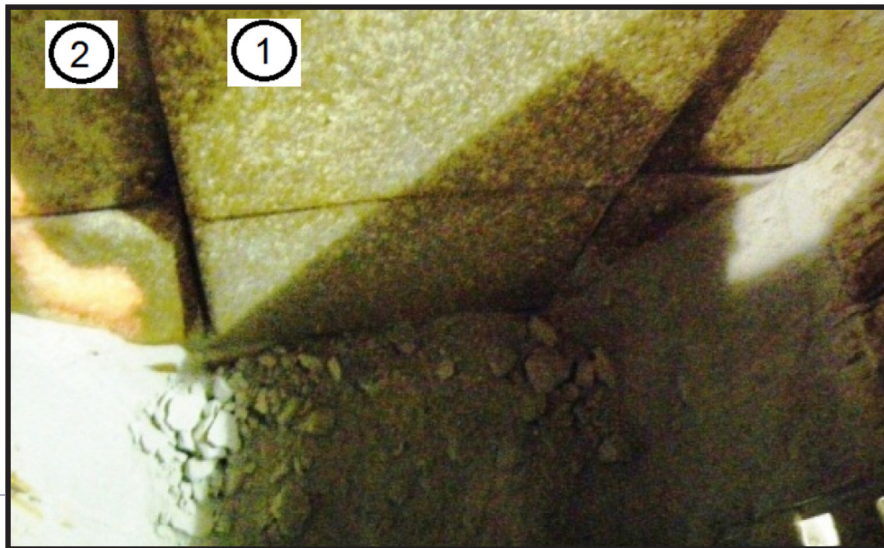
Result: Endura Outperforms Hardox 500 by more than 2X's... and counting!

The photos were taken after a period of time that was DOUBLE the standard life of the Hardox 500 plates in the same location. Despite lasting TWICE as long as the Hardox plate, the material surfaces of the ENDURA 500

are still in excellent conditions and show only minimal wear. Due to the exceptional life-span of ENDURA, more operating hours on the center plate will be required before the full benefits of the material can be realized!
