## Application : Vibratory Grizzly Deck

First Stage Processing of ROM ore typically requires both Impact and Slide Abrasion resistance as lump ore is separated from the fines.

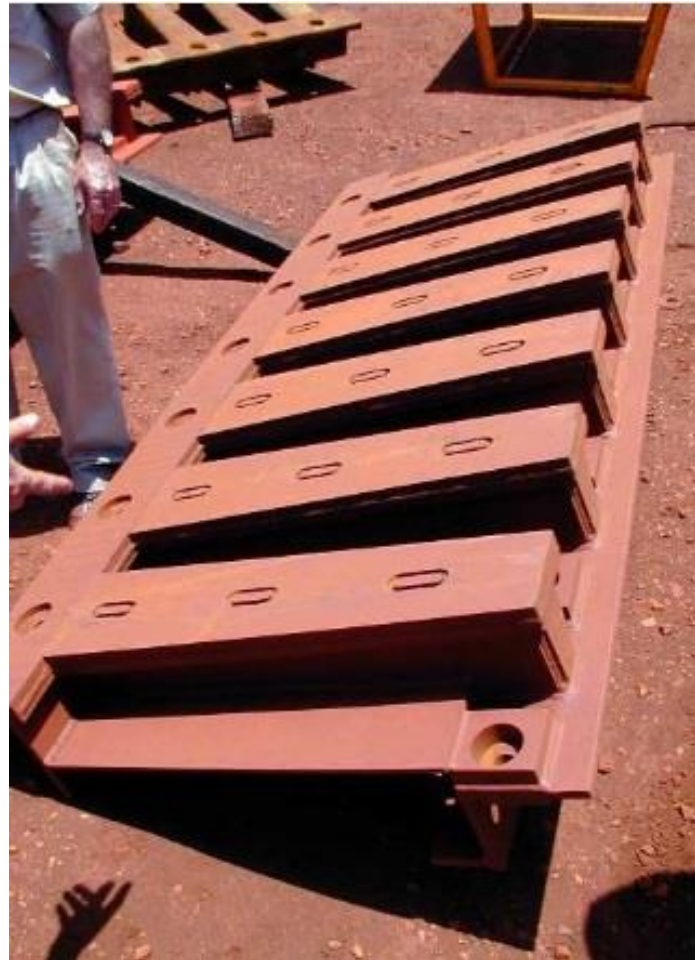
AR 500 was used to line top deck fingers in one unit while **ENDURA** was used in the 2<sup>nd</sup> unit.

AR 500 was providing only 3 months of service.

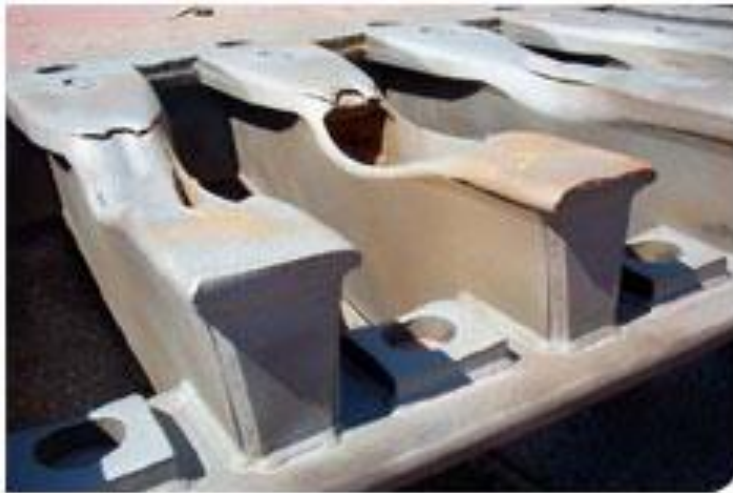
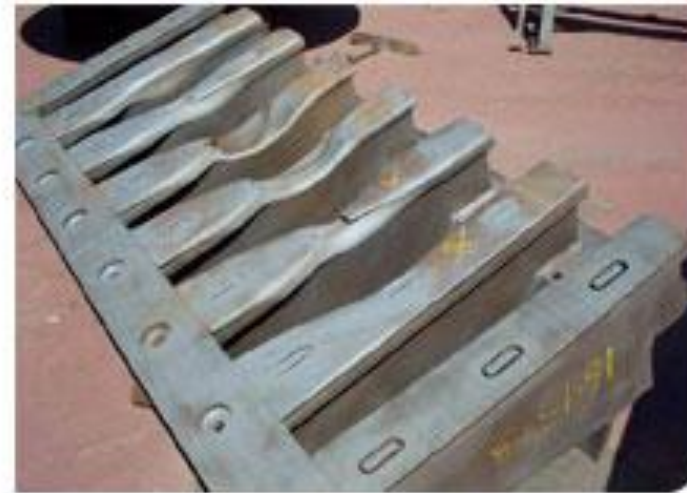
## AR500 – Grizzle Finger after 3 months service – June 2003

The wear on the most critical 'middle section on the AR 500 has worn so severely those sections must be replaced.

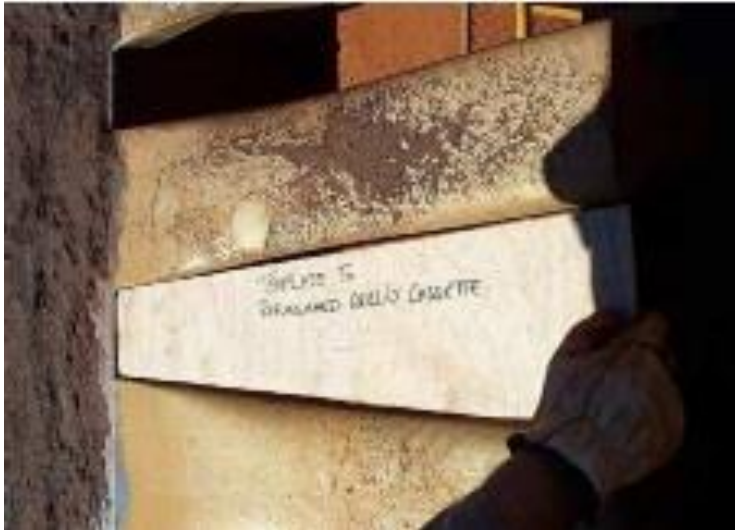
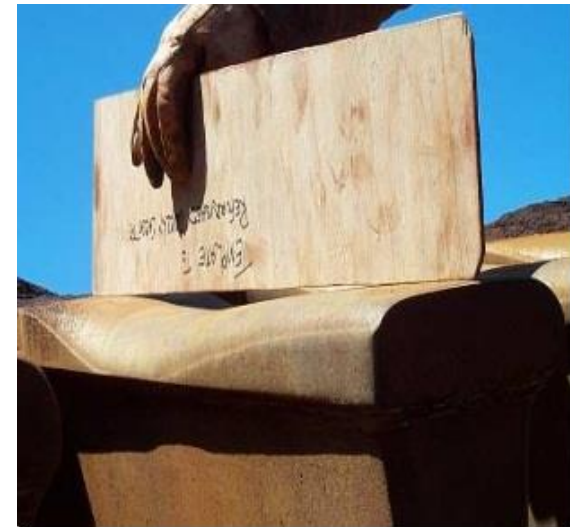
## ENDURA – Grizzle Finger after 3 months service – June 2003

ENDURA Grizzle Deck Fingers show minimal wear and no structural damage.  
ENDURA Grizzle Deck Fingers remain in service.

ENDURA provided 100% + longer service life than AR 500.  
It had been standard over the Past Decade

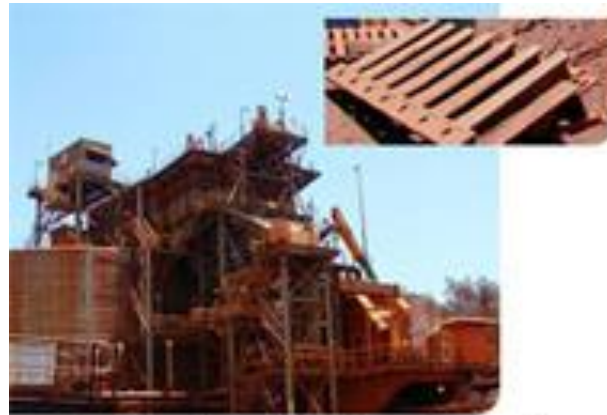
## 2013 UPDATE

*Application Iron Ore Operation  
(fixed plant)*

ENDURA Dual used in field test side by side vs ENDURA.

ENDURA Dual delivered min 50% extended Service Life over ENDURA
